Structural analysis and evaluation of historical Hurman Castle: recommendations for renovation and strengthening

Ömer Arıöz^{1,*} and Halil Aydın²

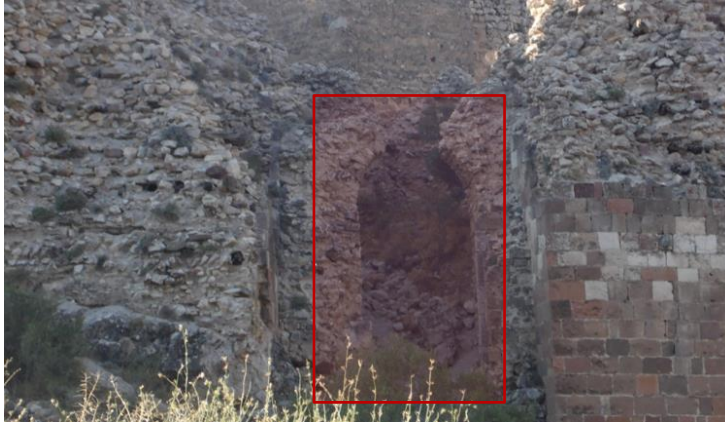
The structural part that stands out on the North Wall is the arched entrance door. The outer wall of the door was completely disappeared and the arch of the door was destroyed around the middle axle. The parts on both sides of the arch stand as a cantilever as it is shown in Fig.3. It was clear that the arch has lost its functionality. It is inevitable that the cantilever parts will be demolished as a result of the vertical effects or slight seismic movements [4].

Fig.3. Arched entrance door in north wall

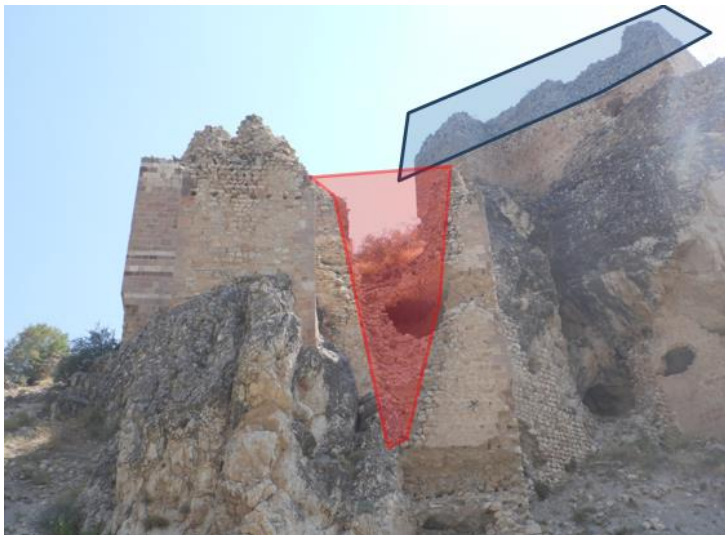
West facade was the place where the most serious problems of the castle is examined from the outside. The main reason for this was that the castle was settled on the steep slope, the signs of the castle were placed in different elevations and these signs were connected to each other by the walls settled in a more irregular form. Therefore, in this section, massive collapses on the walls, deformations from the ground up to the foundation level, as well as demolished wall marks can be seen. In this part, while it can be observed that the outer walls are destroyed in serious amounts, the inner stones are observed, the inner stones decomposed in these facade signs. Much more serious rubble stone slope angles have occurred due to both the sign walls on the slope and the sloping of the inner rubble stones. It should be marked that on the west side of the castle, slopes at a higher level than a natural slope were formed. It can be observed that the slope formed by degradation of the stones reaches about 70 degrees. Fig.4 shows the demolitions in the western side of the castle [4].

Fig.4. Demolitions in the western side of the castle

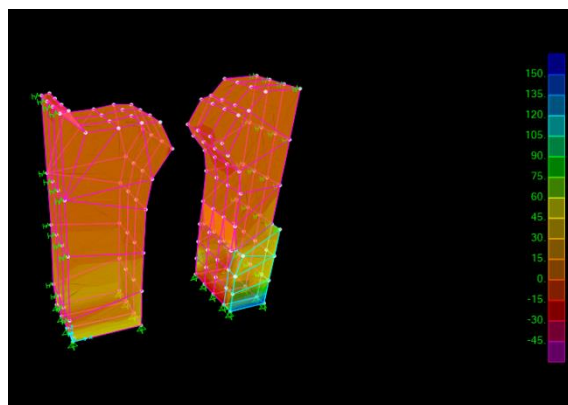
Fig.7. G+Ex stresses on the current gate segment – S11 stress (kPa)

The comparison of two modeling results with DL + EQ combinations in the light of S11 and S22 stresses indicated the need for an improvement. The staging caused by the relatively serious collapses formed in the tower structure was seen as stress accumulation especially in the joints of the cantilever parts. It can be said that the stresses accumulated in these parts of the structure will cause problems for the real situation. As a matter of fact, the relatively small tensile stresses accumulated in the mentioned sections disappear in the models showing the renovated structure. It can be noted that homogeneous distributions in both horizontal and vertical stresses can be obtained by renovating the structure even with partial completions [4-8].

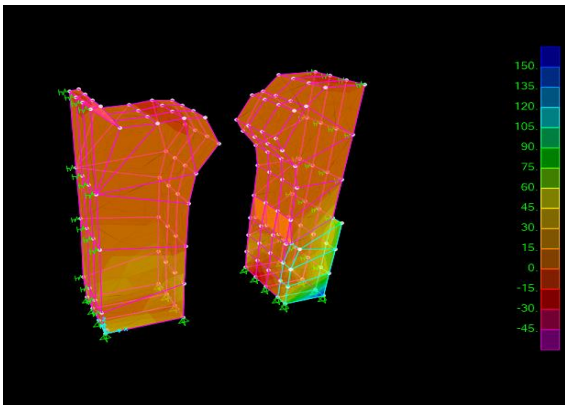
Fig.9. G+Ey stresses on the current gate segment – S22 stress (kPa)

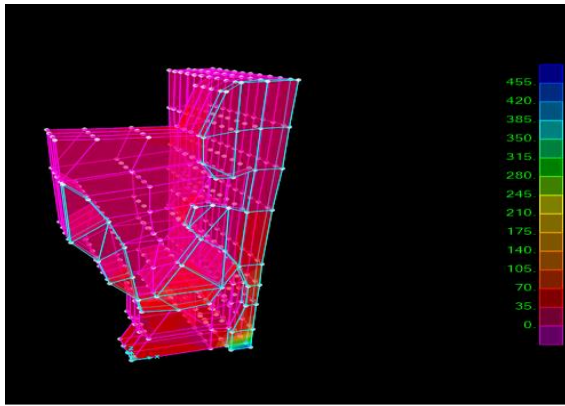
Fig.13. G+Ex stresses on the current sign segment – S11 stress (kPa)

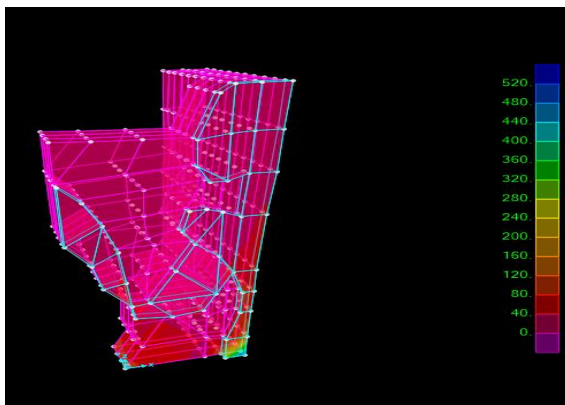
Fig.15. G+Ey stresses on the current sign segment – S22 stress (kPa)
