Leveraging Point Cloud Data for Detecting Building Façade Deteriorations Caused by Neighboring Construction

Abstract: Building facade deterioration due to aging and nearby construction sites is a continuous public safety concern. Within the past half-decade, there have been more than twelve-thousand complaints regarding falling debris from building facades in NYC, where it has around 1 million aging buildings. Thus, an effective method for facade inspection is essential for property owners and inspection agencies. Nowadays, 3D laser scanners are widely utilized for their ability to capture as-is conditions. However, an appropriate scanning setting when facing distinct types of tasks, such as crack detection and progression of damages on building façades is essential to expedite the data collection process. The overarching goal of this research is to compare the datasets captured through different settings of laser scanners (i.e., resolution and scanning distance) for crack detection and to evaluate the measurement accuracy of the detected/progressed cracks. In this study, we report back on the analysis performed on point clouds obtained with terrestrial laser scanners for crack de

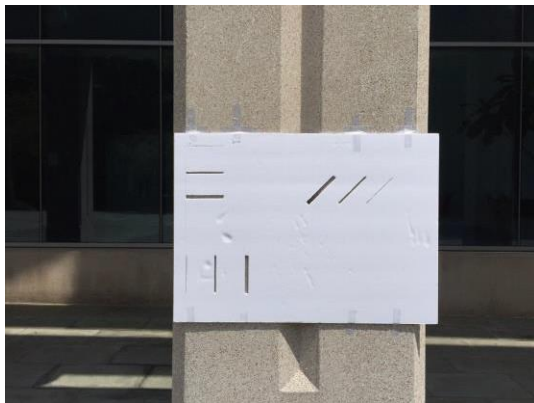
(a). Foam board for cracks simulation.

Cracks were simulated by cutting openings on a foam board. The FARO Focus S 150 terrestrial laser scanner was used for point cloud data collection. The experiment set-up is demonstrated in Figure 1 (a) and (b). A digital laser distance meter (Figure 2 (a)) was used to control the range from the laser scanner to the target plane. Since the simulated cracks are manually cut, the value of crack width and length might not be the same as designed. Crack width and length measured by a digital caliper (Figure 2 (a)) with accuracy up to 0.01mm are set as the ground truth, and the actual values are shown in Table 2.

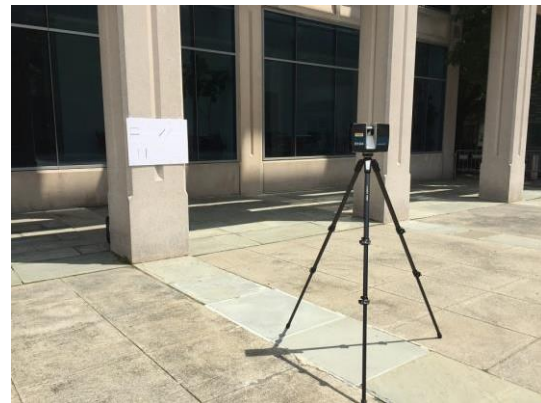
(b). Scanning set-up.

Figure 1: The experiment set-up.
