Structural analysis and evaluation of historical Hurman Castle: recommendations for renovation and strengthening

Ömer Arıöz^{1,*} and Halil Aydın²

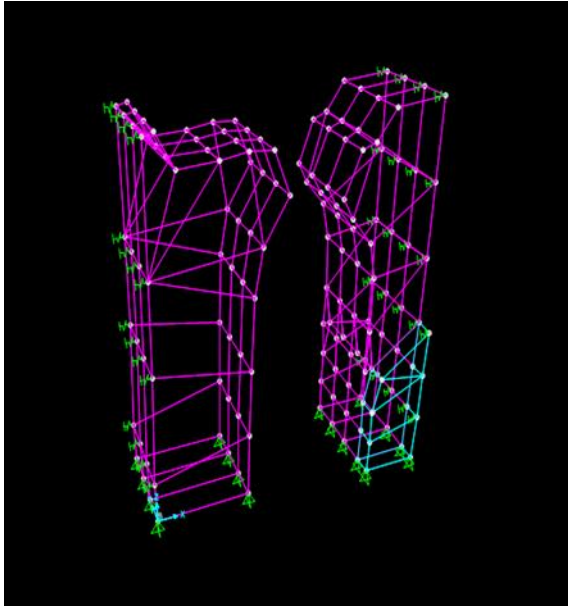
Fig.5. Model of current north front entrance gate segment

Since Hurman Castle was subjected to serious local demolitions, models of sample structure parts were used to examine the current state of the building. In the models; on the north side, 152 points 67 solid elements; on the west side, 436 points, 265 solid elements were used. The ground relation of the lowest row walls of the castle was defined with hinge elements. Load types on the models are limited by their own weight and lateral earthquake effects. In vertical loads, no load was taken, which the structure was exposed to, other than its own weight [4-7]. Fig.5 and Fig.6 present the models of current and proposed renovation of north front entrance gate segment, respectively. Fig.7 and

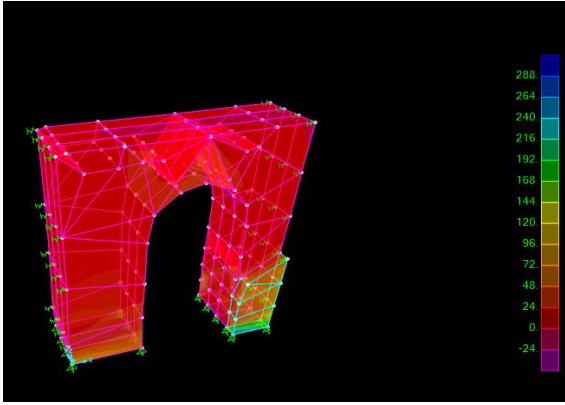
Fig.8. G+Ex stresses on the gate segment of proposed renovation – S11 stress (kPa)

Fig.8 show G+Ex stresses (S11) on the current and proposed renovation of gate segment, respectively. Fig.9 and Fig.10 present G+Ey stresses (S22) on the current and proposed renovation gate segment, respectively [4].

The comparison of two modeling results with DL + EQ combinations in the light of S11 and S22 stresses indicated the need for an improvement. The staging caused by the relatively serious collapses formed in the tower structure was seen as stress accumulation especially in the joints of the cantilever parts. It can be said that the stresses accumulated in these parts of the structure will cause problems for the real situation. As a matter of fact, the relatively small tensile stresses accumulated in the mentioned sections disappear in the models showing the renovated structure. It can be noted that homogeneous distributions in both horizontal and vertical stresses can be obtained by renovating the structure even with partial completions [4-8].

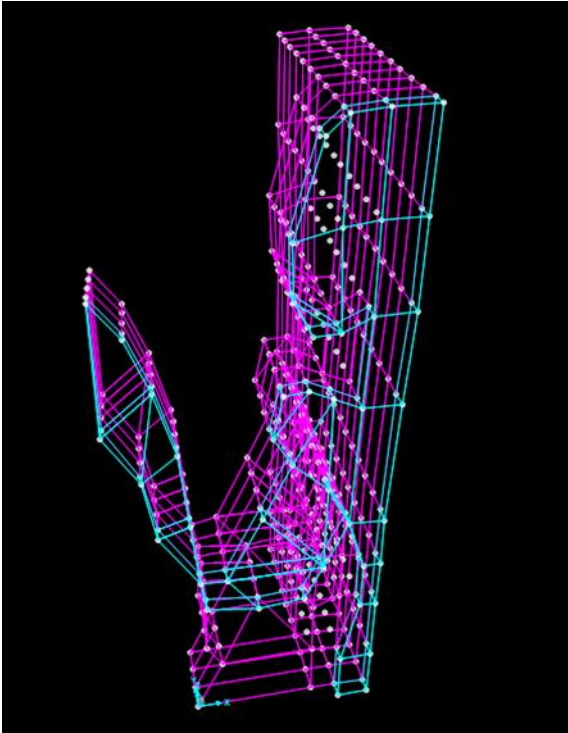
Fig.11. Model of current west front sign segment

Fig.11 and Fig.12 show the models of current and proposed renovation of sign segment on the west side, respectively. Fig.13 and Fig.14 show G+Ex stresses (S11) on the current and proposed renovation of sign segment, respectively. Fig.15 and Fig.16 present G+Ey stresses (S22) on the current and proposed renovation sign segment, respectively [4].
